RDTR NO. 160
3 DECEMBER 1969

SAFETY TEST OF FLARE EXTRUSION FACILITY

**RESEARCH AND DEVELOPMENT DEPARTMENT
NAVAL AMMUNITION DEPOT, CRANE, INDIANA**

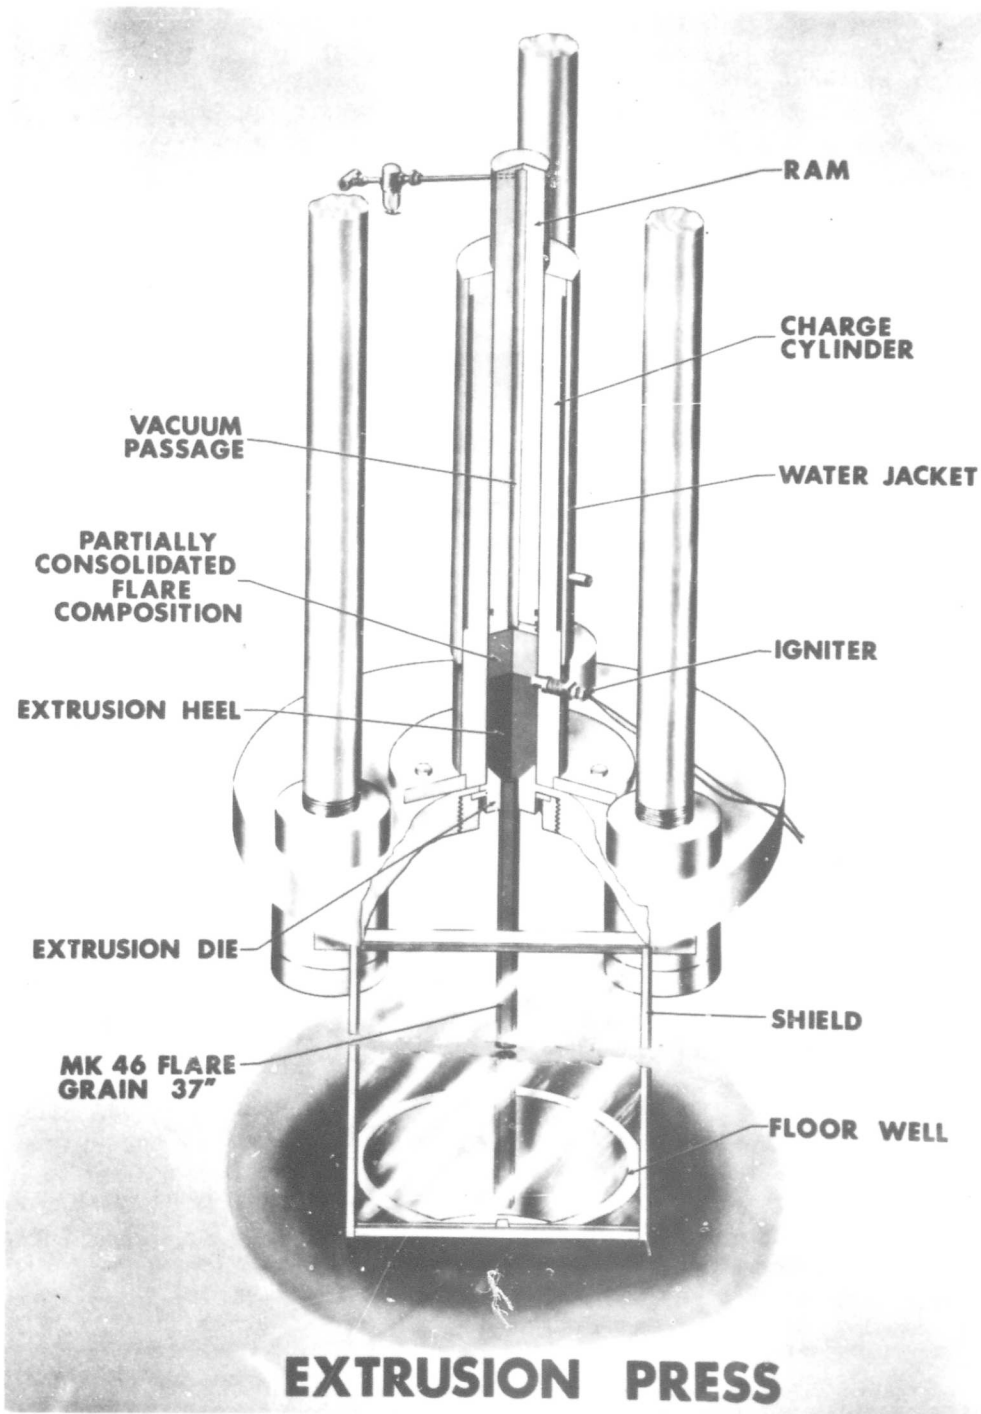
Figure 2
13

grain. The press was loaded with seven pounds of MK 46 flare composition, so as to simulate a point in the extrusion cycle at which an accidental ignition might occur. Figure 2 is an illustration of the press as loaded for the test.

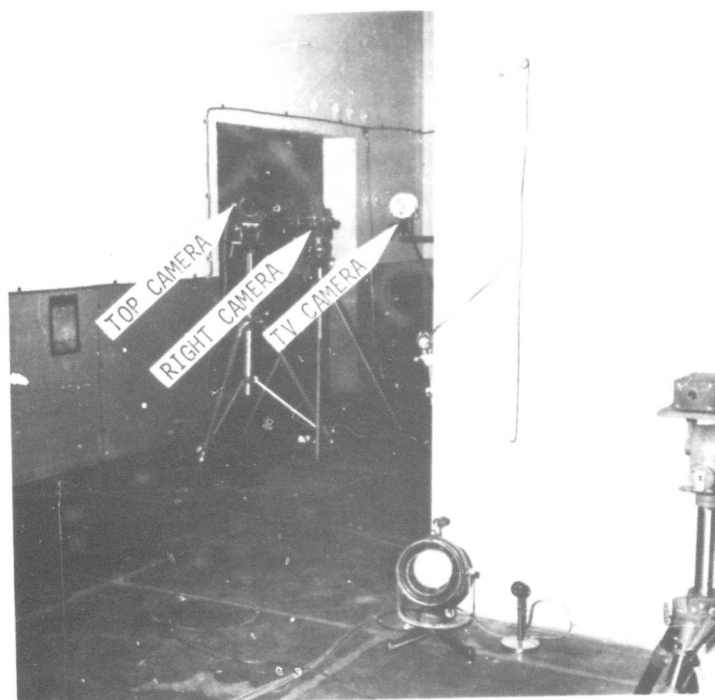
FIGURE 4b RIGHT AND TOP CAMERA

Instrumentation was set up in and around the press cell to collect temperature, pressure, toxicity, audio, and photographic information. Four 16mm movie cameras, running at 24 frames per second, were used. Figure 4a shows a camera aimed at the press cell from the left side. Figure 4b shows one camera aimed at the cell from the right side and another aimed

at the top of the cell. It also shows the TV camera used to monitor the test. Figure 5a shows the blowout windows before the test and the location of the outside camera which was aimed toward the bottom of the press. Two of the polyethylene panes were replaced with clear polystyrene panes. Figure 5b shows the location of two photocells mounted on tripods and thermocouples, T1, T2, and T3. The photocell on the left detected visible energy and the photocell on the right detected infrared energy. Figure 6a shows the location of T4 and a pressure transducer. T5 was located on the press as shown by Figure 6b. Figure 3 also shows small pieces of newspaper taped to the doorway. Paper was also taped to the walls inside the cell at various locations. A book¹ by the AEC provides information with which a relationship can be made between the radiation energy level required to ignite newspaper and the radiation energy level that causes skin burns. From tables 7.45 and 7.65, it can be seen that the energy required to ignite newspaper would at least cause first degree burns and probably second degree burns. Flash time was also considered when making the relationship.
